# DURACLUTCH INSTALLATION 15-538 K-DCR RZR AND RANGER MIDSIZE 570 R-SERIES

SVI, LLC 29JUL2022REV8

KIT PART #: 15-538

MODEL: DCR-RZR RANGER 570

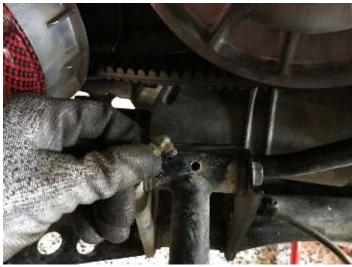
1. Remove clutch cover. Note: on some models it may ease cover removal by removing grease zerk on control arm.

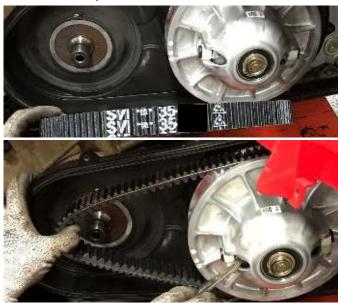
- 6. Clean the engine tapered shaft and Primary clutch bore with alcohol or degreaser. Do not lubricate.
- 7. Slip the belt into the Secondary so you can read the part number on the belt and using Belt Install Tool, open secondary so belt will seat down into clutch. Sometimes using a screwdriver to support the tool will help seat the belt lower into clutch.

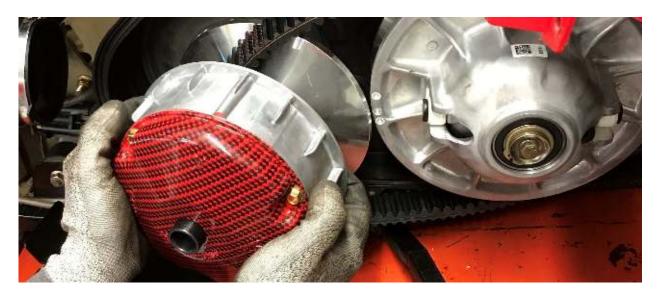
8. Slide belt into DURACLUTCH DCR Primary clutch then install on post. Use stock primary hardware removed in step 5. Tighten bolt to 47 ft-lbs.
