DURACLUTCH INSTALLATION

15-503 DCG1-RZR900-B

DESCRIPTION: MY15 RZR 900 ALL MODELS

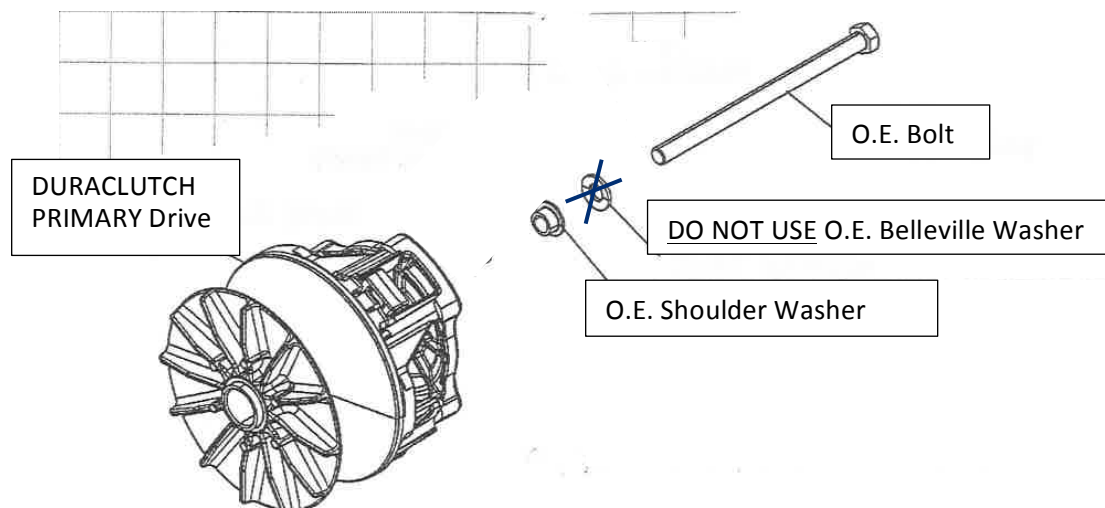
1. Remove the Secondary clutch.
2. Install DURACLUTCH Secondary. If there is a snap ring behind the Secondary, remove it. Tighten bolt to 48 ft-lbf.
3. Remove Primary clutch bolt. Remove the Primary clutch with a puller (SVI 25-147). Greasing the end of the puller slightly will aid in removal. Do not get grease on any clutch components.
4. Clean the engine tapered shaft and Primary clutch bore with alcohol or degreaser. Do not lubricate.
5. Slip the belt into the Primary and over the Secondary.
6. Install DURACLUTCH Primary with shoulder washer as shown. DO NOT USE the O.E. flat washer. It may interfere with the primary cover. Tighten bolt to 60 ft-lbf.

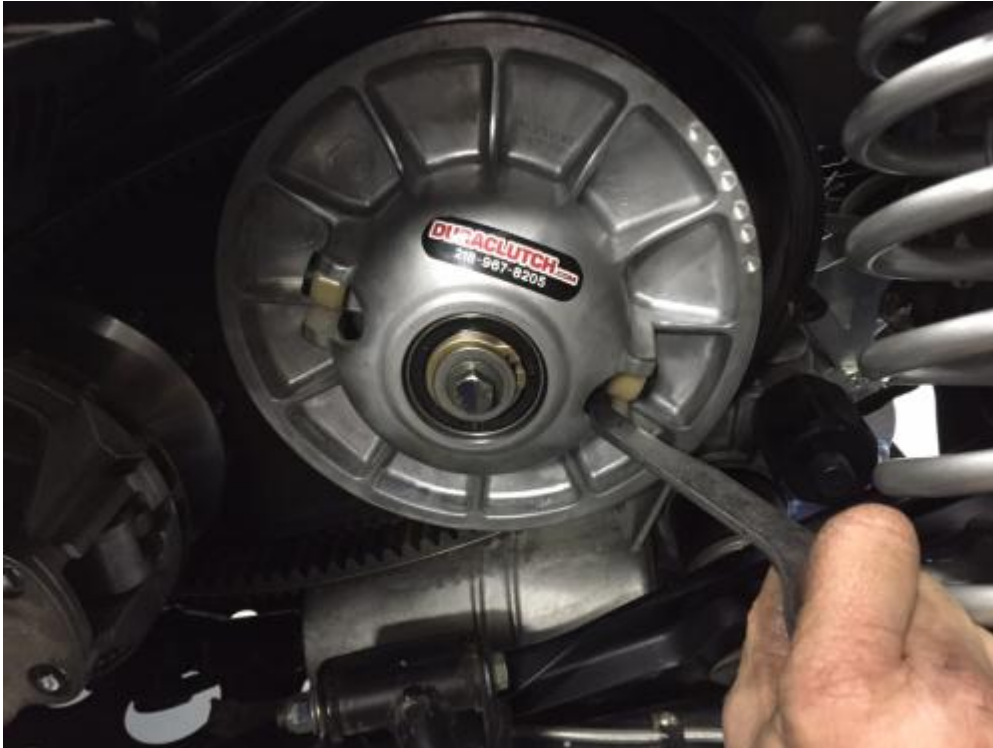
7. Install the Belt as follows if the Primary and Secondary are already installed. Place Belt in the Primary and open the Secondary sheaves with the Belt Installation Tool provided (see photo). Roll belt into the Secondary sheaves.

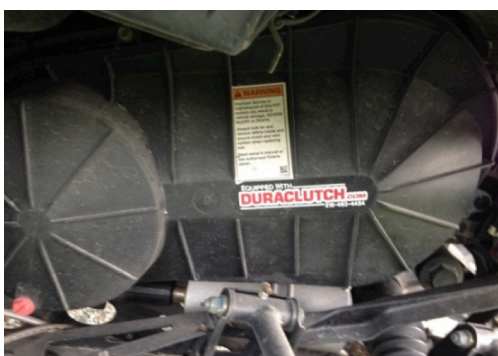
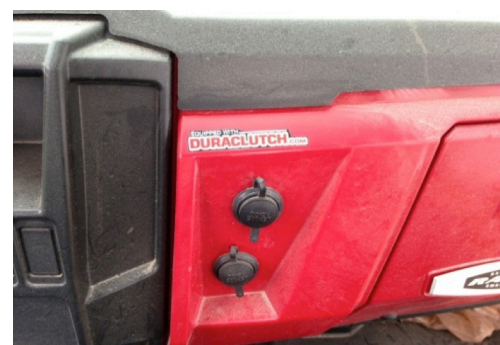
DECALS

10. Apply two decals as shown – one on the clutch housing and one on the dash. Clean surface with alcohol or similar solvent. Decal application is important to alert service technicians that the standard Polaris clutches have been replaced.
